NAVORD REPORT 3670

A STUDY OF THE EFFECTS OF STATIC ELECTRICITY ON LOW INPUT ENERGY
ELECTRIC INITIATORS OF THE CARBON BRIDGE TYPE

5 AUGUST 1954

U. S. NAVAL ORDNANCE LABORATORY
WHITE OAK, MARYLAND

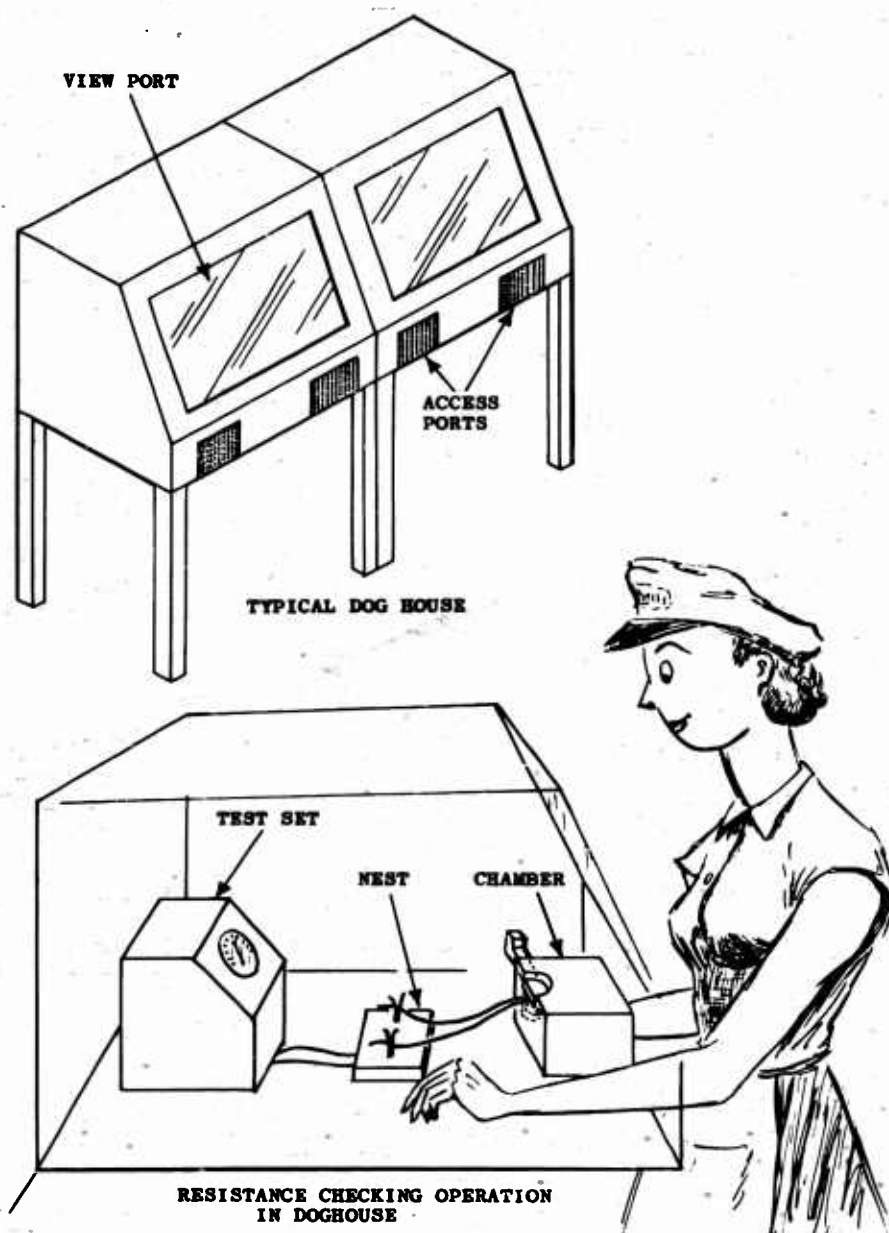
FIG.1 OPERATION ENVIRONMENT DURING 1 OCT AND 8 OCT ACCIDENTS

9. The entire operation is carried out in an enclosure of the type shown in Figure 1. This enclosure, known as a "doghouse," has a steel floor and framework. The operator is grounded by a coil spring type wrist bracelet of the type shown in Figure 2. Dangling grounding chains of the bathtub stopper chain type were spaced about every quarter of an inch across the ports into which the operator inserted her hands. It was found by measurement with an electrostatic voltmeter that these grounding chains were in some instances ineffective against static potentials generated by an operator. At the time of the accident it is probable that the doghouses were not connected to the driven ground provided for the purpose. The doghouses did provide a mechanical support for the fluorescent fixtures which are, in turn, referenced to ground via the electrical conduit system. It is not likely that the resistance of the ground return of the doghouses could have exceeded 10 ohms.

10. The ready box in which the 1 October explosion occurred was resting on a steel well which was set into and electrically in contact with the floor of the doghouse. The resistance from a similar ready box, placed in about the same position to the point of attachment of the grounding wire to the wrist bracelet was less than 5 ohms. It was noticed that the resistance between two diametrically opposed points on the bracelet was about 10 ohms. This is due to the resistivity of the stainless steel used in making the watch band. However a 15 ohm ground return resistance can be considered a short circuit in comparison with ordinary body skin contact resistance.

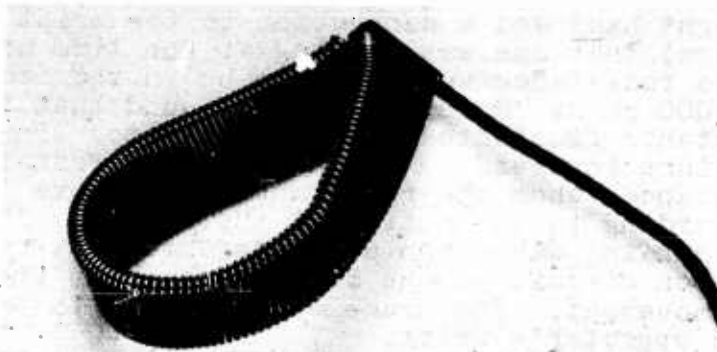
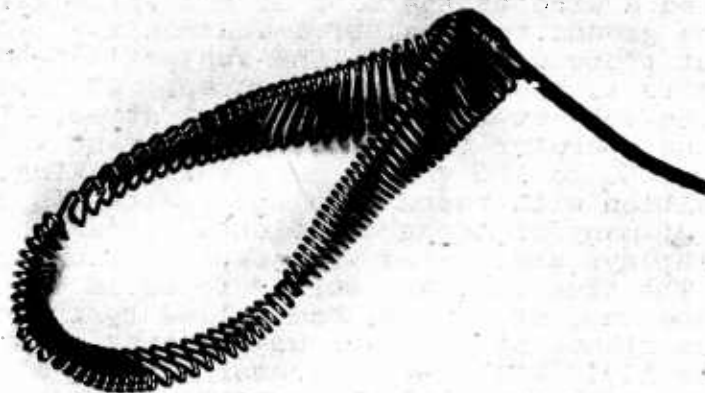
FIG. 2 WRISTLETS WORN DURING 1 OCT AND 8 OCT ACCIDENTS

WRISTLET WORN BY OPERATOR DURING 1 OCT ACCIDENT

WRISTLET WORN BY OPERATOR DURING 8 OCT. ACCIDENT.

11. The operator's body resistance was measured with a battery powered volt-ohm-milliammeter between a test lead held in her right hand and a connection to the wrist band (on her left arm) that she was wearing at the time of the accident. This resistance was found to be in the order of 50,000 to 100,000 ohms. However, it was found that this value of resistance fluctuated when the operator simulated the normal motions involved in checking primer resistance. There were instances when the resistance went above 5 or 10 megohms according to the motion of the needle. It is likely that grounding was momentarily defeated but not indicated as open circuit on the meter because of the inertia of the needle movement. The bracelet was found to fit rather loosely on the operator's wrist.

16. Much less detailed information is available concerning the circumstances of the 8 October accident. The operator was in the habit of wearing her grounding band on her upper arm. That the grounding band was stretched (probably for comfort) is known. How well it maintained contact is not known. Since the accident occurred while the primer was in the safety chamber, it is possible that the test circuitry may have in some way contributed to the firing. The fact that the operator's finger was in the blast area indicates that the hand may have been in some way involved with the primer leads.

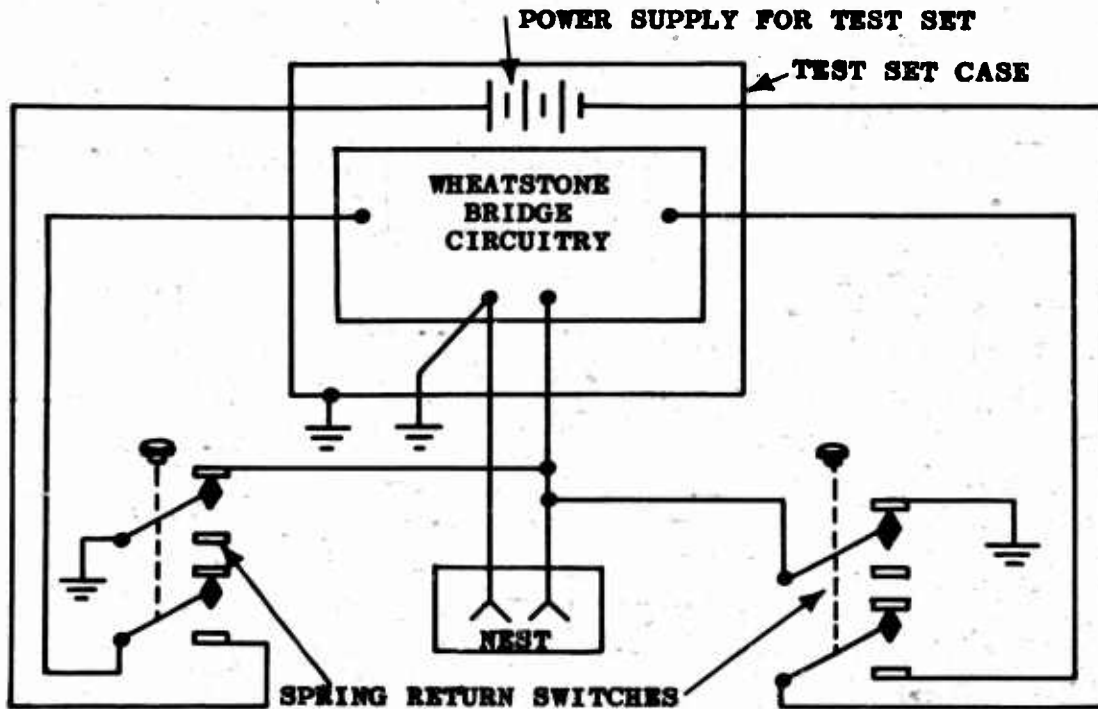
FIG. 4 SUGGESTED ARRANGEMENT OF TEST SET MK 162 MOD 1 CIRCUIT

18. The lack of grounding of the circuit of the test set is inherently a dangerous condition. As was pointed out in reference a., this particular arrangement could store enough energy on the insulated circuit to fire a primer. The energy thus stored can be derived at some time previous to a primer handling cycle and is thus a latent source of trouble. Since there are a number of quite different ways in which this arrangement can act adversely, it is possible to conjecture a number of different circumstances attributable to the isolated circuit, whereby the 8 October accident could have happened. In order to eliminate the isolated circuits, it was decided to ground the instrument circuits and cabinets of all the test sets on the line. This led to a new effect. Because of the peculiarities of the circuit, an operator touching the steel floor of the work enclosure and the ungrounded spring brass terminal of the nest, could cause the meter needle to deflect from zero, even with the test set power turned off. This was due to the galvanic action between the steel and brass using skin moisture as the electrolyte and the microammeter as the return path. However, the current that resulted from the galvanic potential was quite small, less than that which could flow through the primer from the test set. In any case, the maximum e.m.f. derivable from a single cell is well below the presently known lowest voltage at which a primer of this type has been fired.

19. It is not good practice to have an electrical test circuit energized at the time an electro-explosive unit is connected to it. True, the basis of the design of the

test circuit is that the maximum current put-through is still safe by a large margin. However, it is normally possible to devise some method, by mechanical interlock or by operational requirement, whereby the power to the primer is applied only after the operator is completely protected. In the present instance, it seems that a good modification of the circuit, as in Figure 4, might be to install two push button, double throw switches, one for each hand, at points that would move the operator's hands well away from the safety chamber and from the primer containers. By this switching arrangement it would insure not only that the

power to the test circuit would not be turned on till both hands are out of harm's way, but also that both leads would be shorted to ground. This would eliminate the galvanic effect mentioned in the previous paragraph, in addition to giving electrical grounding of the connected primer except during actual testing.

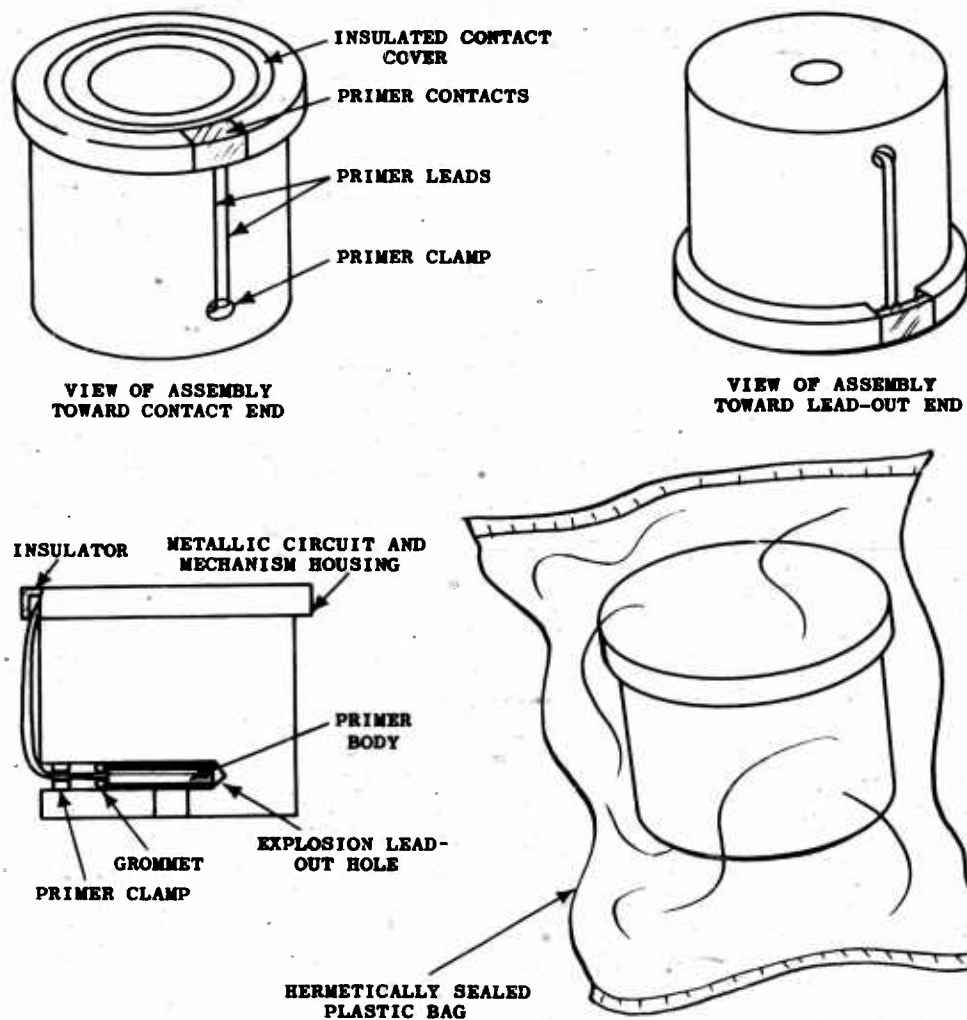
FIG. 5 VIEWS OF THE ASSEMBLY AND POLYTHENE BAG OF THE
TYPE THAT FIGURED IN THE 20 NOV AND 2 DEC ACCIDENTS

Among other things, the circuitry provides an electrical short across the primer leads. The grounding is to the metal frame of the assembly. Figure 5 shows an artist's conception of various views of this assembly demonstrating the salient features pertaining to this and the following accident.

28. An inspection of the shorting circuit mechanism was made. Certain contact members which are normally held firmly in place were found to slide. Personnel of Plant B had found that by shaking the assembly it was possible to obtain occasional readings on a volt-ohm-milliammeter of 10 ohms. It is probable that the momentary maximum values of resistance could have been much greater than 10 ohms. Whether this condition of the shorting circuit was brought about by the primer blast or whether it existed before is not known. Subsequently other assemblies of the same lot were tested at the Naval Ordnance Laboratory. A primer was connected by extra leads to the two terminal points to which would be connected the primer installed in the assembly. These two points are normally electrically connected by the internal shorting mechanism. An external battery and resistor were connected in series with the terminal pair. With this arrangement, any momentary opening of the short circuit, even as short a time as a few microseconds, should cause the primer to fire. In one of the assemblies tested, a tap with a light hammer defeated the short. In another instance, the short was defeated by the slight disturbance created by picking up the assembly.

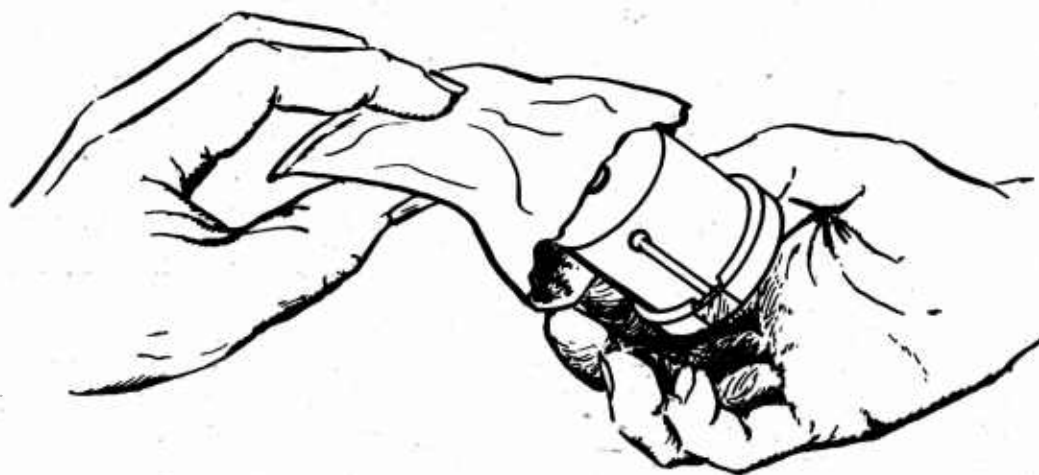
FIG. 7 REMOVING ASSEMBLY FROM PLASTIC BAG

When these assemblies are completed by Plant A, they are put in heat sealed polythene bags to keep out foreign material and moisture, and then are put into cardboard "egg-crate" type shipping containers, each assembly isolated from the next by a complete surround of cardboard. The first operation in Plant B prior to 20 November in handling these assemblies was to take out a tray of 42 and place it on a felt covered steel bench, as in Figure 6. The next step was to cut open the tops of all the bags and then to remove each assembly from its bag by spilling it out as in Figure 7.

23. As well as the operator can remember, she was involved in the "spilling" process when the primer fired. She received numerous cuts and burns and particle embedment on various portions of the face, embedment just below the left collar bone and some minor cuts and burns on one hand. The sound wave brought about a temporary deafness. Miraculously, she escaped optical injury or cutting of major blood vessels in the neck or forehead.

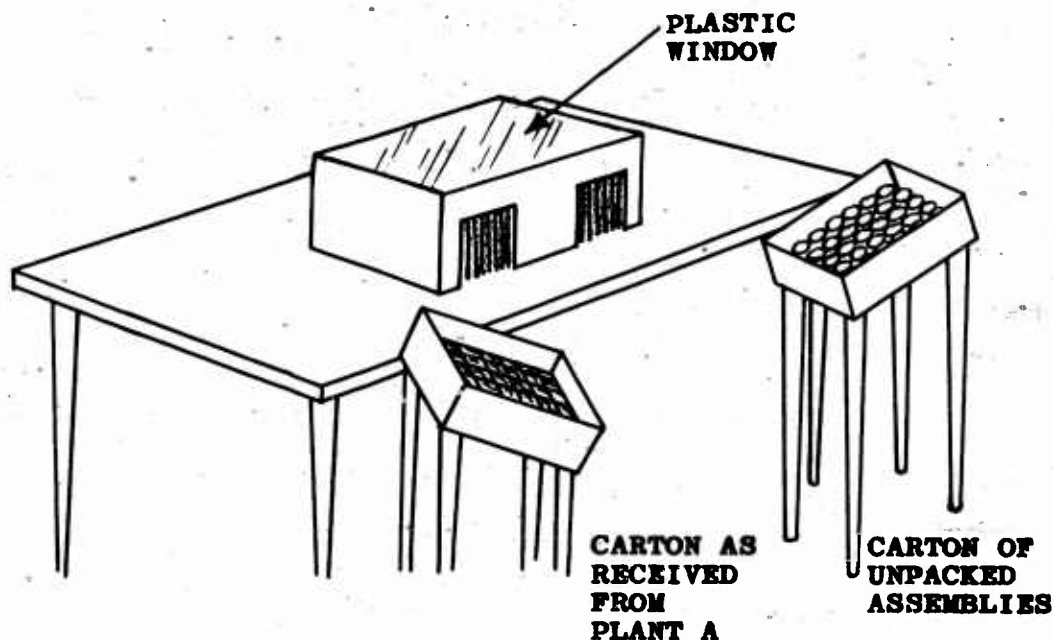
FIG. 8 UNPACKAGING STATION AT PLANT B ON 2 DEC 1953.

The packaged assemblies were removed singly from the shipping container at the left and set down on the steel table inside the shield. The bag was cut open, the assembly spilled out and then placed with the right hand in the box of unpacked assemblies. The unpacked assemblies are placed touching each other in layers on a cardboard sheet which separates the layers. The box is also cardboard.

Either as the operator was setting the three assemblies down, or as she was moving her hand away, one of the primers fired before the bag had been cut open. Her involuntary sudden motions away from the explosion area caused her to scrape the back of her right hand on the enclosure. The location of the assembly at the instant of the explosion can be deduced from the denting of the steel work table surface. The assembly must have been standing with its axis of symmetry vertical and with the lead out hole downwards. The assembly must have been standing very nearly as close to the rear wall of the enclosure as its plastic bag would allow it and no more than a quarter of an inch above the surface of the table. The orientation of the side hole cannot be deduced from the available evidence.

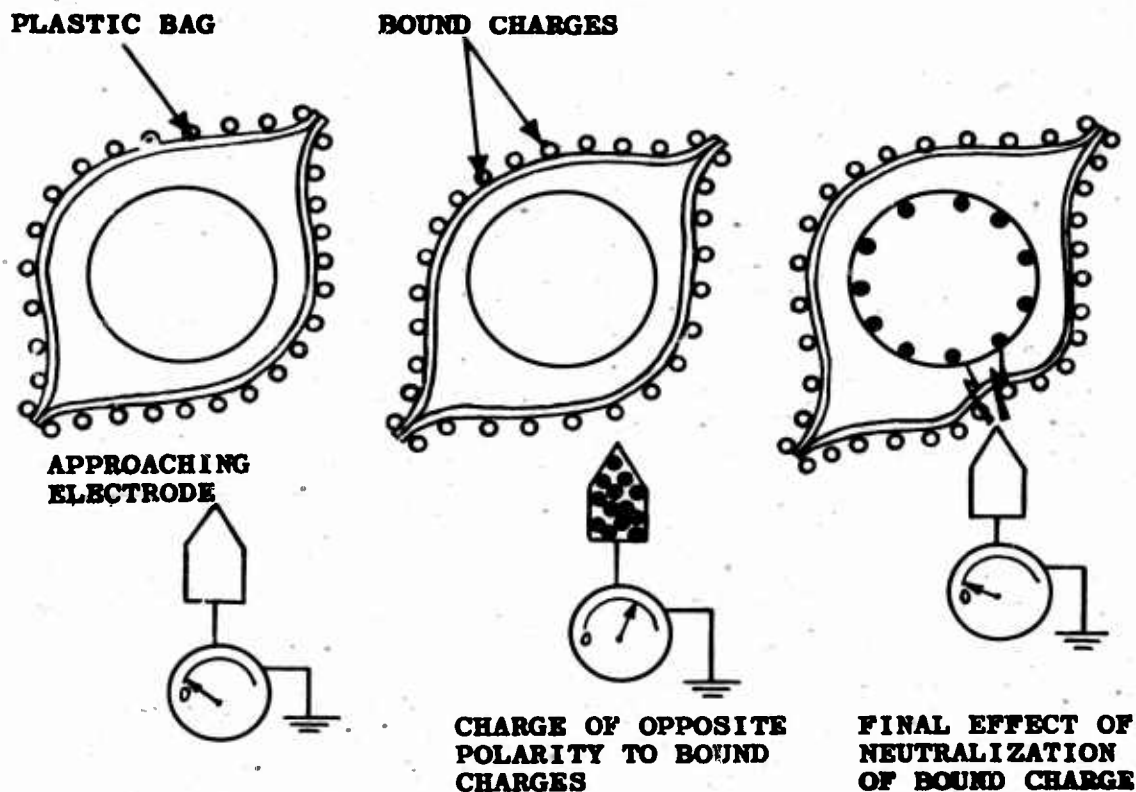
FIG. 9 EXPLANATION OF CHARGING ACTION THROUGH PLASTIC BAG

29. In attempting to find a basis for explaining the 2 December accident it is first necessary to find out how the charge could have been formed. The act of removing the bagged assembly from the egg-crate dividers could generate a static charge on the outer surface of the plastic bag and an equivalent opposite charge on the cardboard. The energy flow associated with firing the primer would not necessarily require a dielectric breakdown of the plastic bag, although such an action is most likely. By a change in physical orientation of the various conductors and insulators it is possible, by capacitive induction, that

there would be sufficient displacement currents to fire the primer. Another hypothesis is tenable. If the original charge were to act as if it were on the assembly, it could discharge through the primer lead wires to the rear wall of the enclosure, or to an adjacent assembly, or to the operator's hand. Once a bound charge is accumulated on the outer surface of the bag, the assembly inside the bag would act as a conductor in such a way that a flow of energy to some point on the assembly would be distributed to attempt to neutralize the field due to the bound charges. Figure 9 is an attempt to portray this action. It is barely possible that the charge could have dissipated through the leads to case and then from the case to the work table top through the explosion lead-out hole. If the charge were to have been collected on something other than the assembly in which the explosion occurred -- for instance, the operator or an adjacent assembly -- the discharge could take place through the assembly and primer wiring to the grounding enclosure or to another assembly.

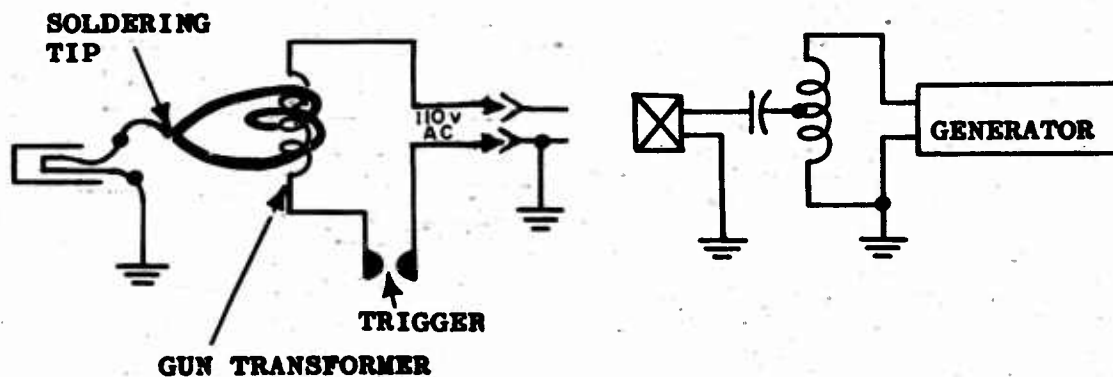
FIG. 10 SYMBOLIC REPRESENTATION AND CIRCUIT ANALYSIS OF THE ACTION OF THE WELLER GUN ON MK 121 PRIMER

33. Tests subsequently performed at the Naval Ordnance Laboratory indicated that peak potentials could be generated across a primer bridge of 80 to 100 volts if one unshorted lead of the primer is in contact with the gun tip and the other lead grounded. Figure 10 shows the electrical physical arrangement and the circuit analog. It is not as likely that the voltage pulse was derived from magnetic coupling as that it resulted from the capacitance existing between the windings. The association of the pulse with trigger action turning the gun either on or off can be explained on the basis of inductive "kick". Due to the induction of the primary winding, the opening or closing of power to the winding usually causes a momentary peak voltage to appear across the winding. This voltage peak may be considerably greater than the normal supply voltage. As part of the test at the laboratory, six Mk 121 primers were fired

in the arrangement shown in Figure 10. It was not possible to fire the Mk 121 primer when the leads were twisted together nor was it possible to fire a Mk 114 primer

34. In reviewing this accident, it is possible to see that two fundamental rules had not been followed. First, the explosive operation had not been carried out in an adequately shielded area. Second, an improper soldering iron had been used. In working with electro-explosive devices, it is imperative that a heating element type soldering iron with grounded tip and element insulated from the tip should be used. Even better would be a grounded iron which does not have any heating element but is kept at the proper temperature by resting in a separate heater. In the case of an iron with a heating element, it should be designed to keep to a minimum the capacitive and magnetic coupled fields due to the wiring contained within the iron. An iron having a thermostat might be dangerous due to switching surges during operation of the thermostat.
